# Iowa City Transit Facility – Existing Conditions

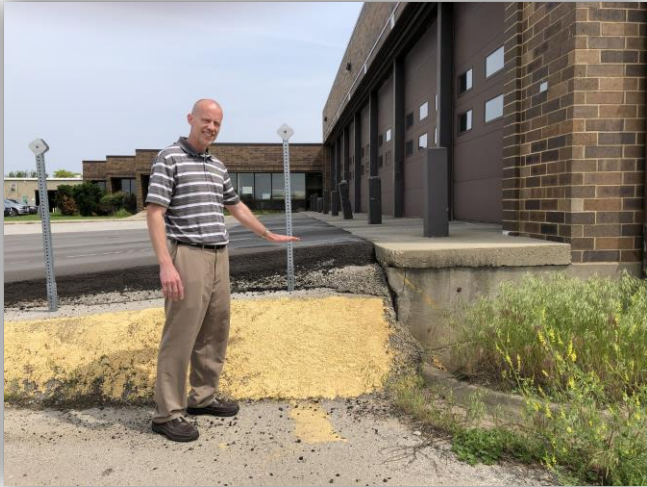
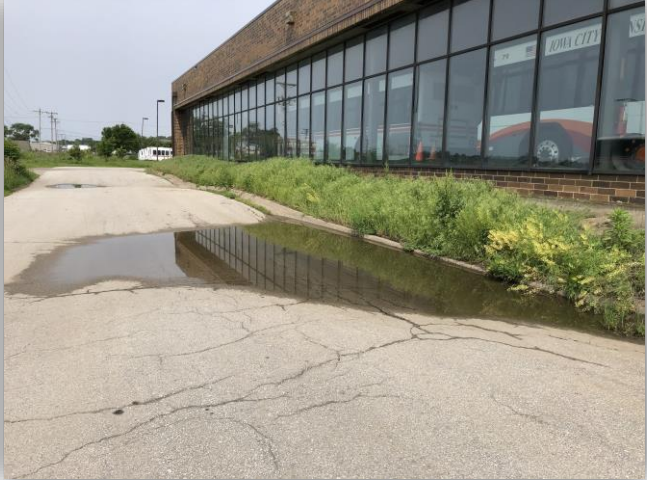
## Ground Subsidence

*Asphalt patching, persistent ponding of water, wetland formation, potholes, uneven surfaces are common and cause hazards for vehicles and pedestrians.*

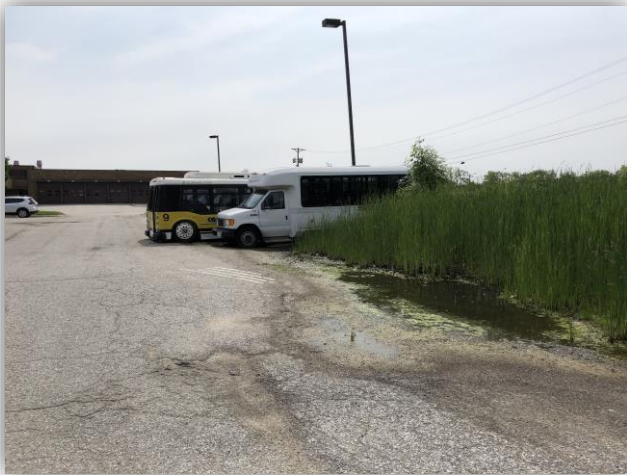
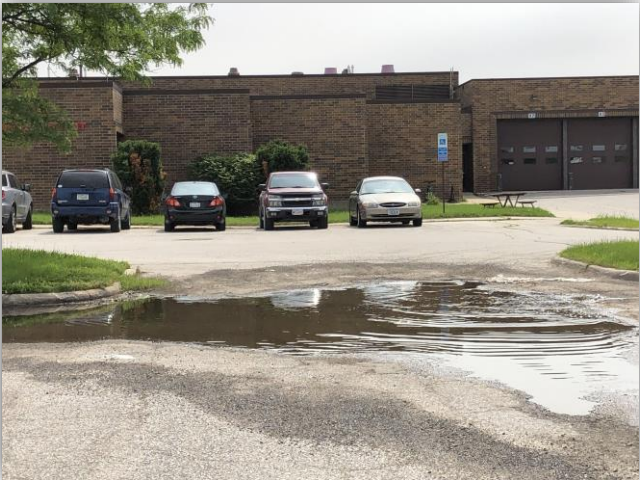
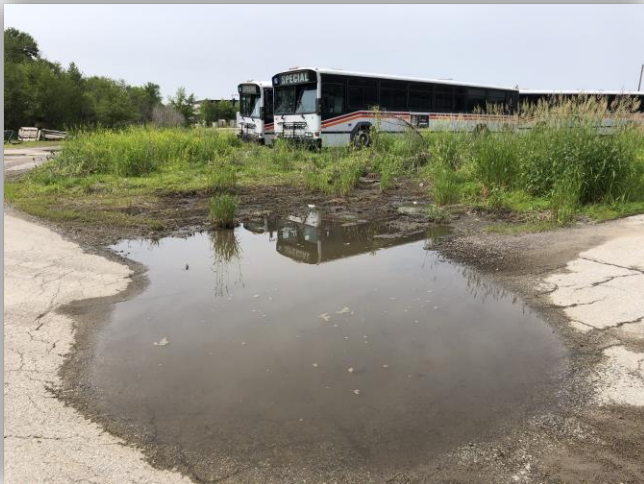
*Annual asphalt patching required to ensure buses have an adequate slope to enter/exit the building.*

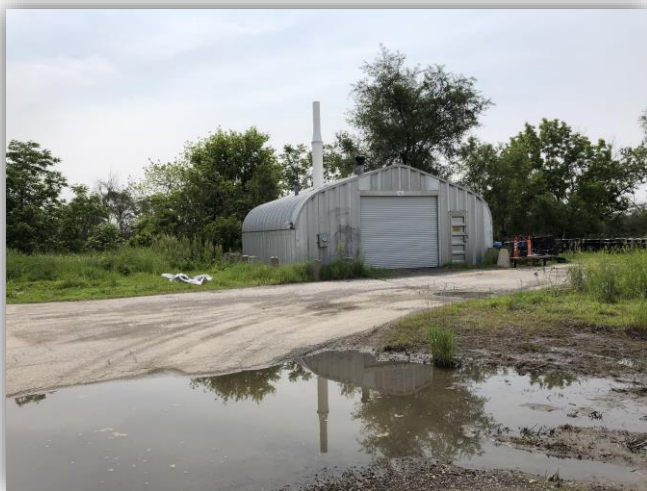
*The silver building houses methane abatement equipment. There is also extensive equipment below the facility and methane monitoring equipment located throughout the building.*

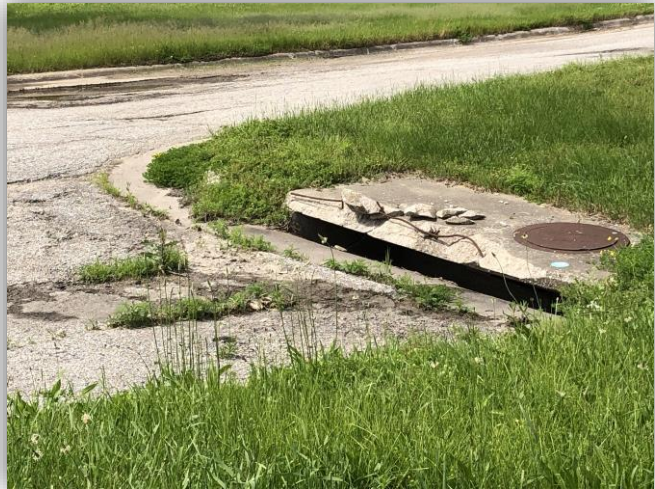
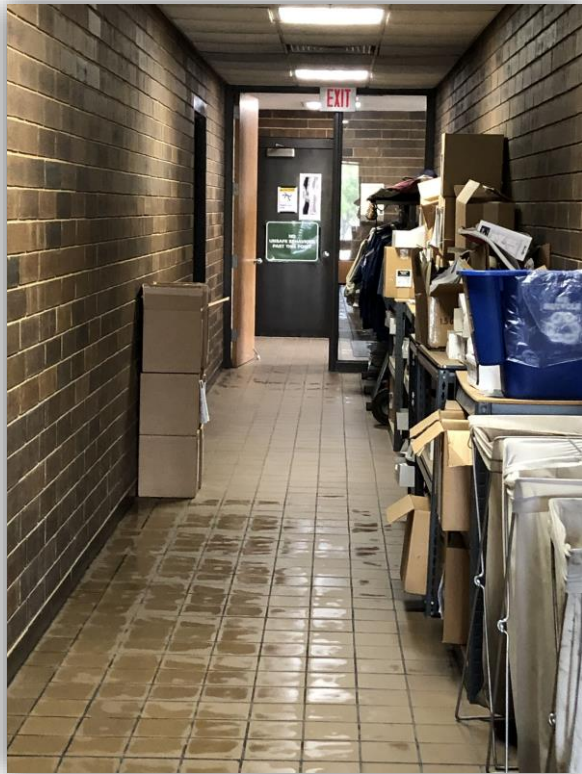
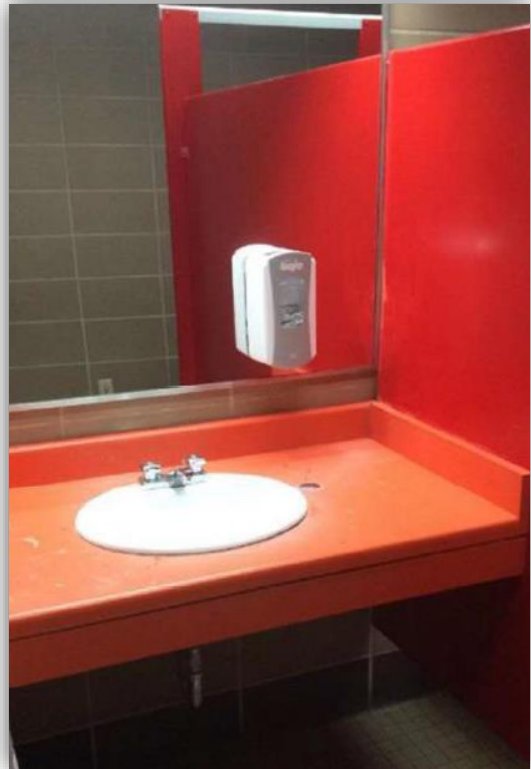
*Lack of storage requires repurposing of hallway.*

*Outdated furnishings and built-in equipment reaching the end of their useful life.*

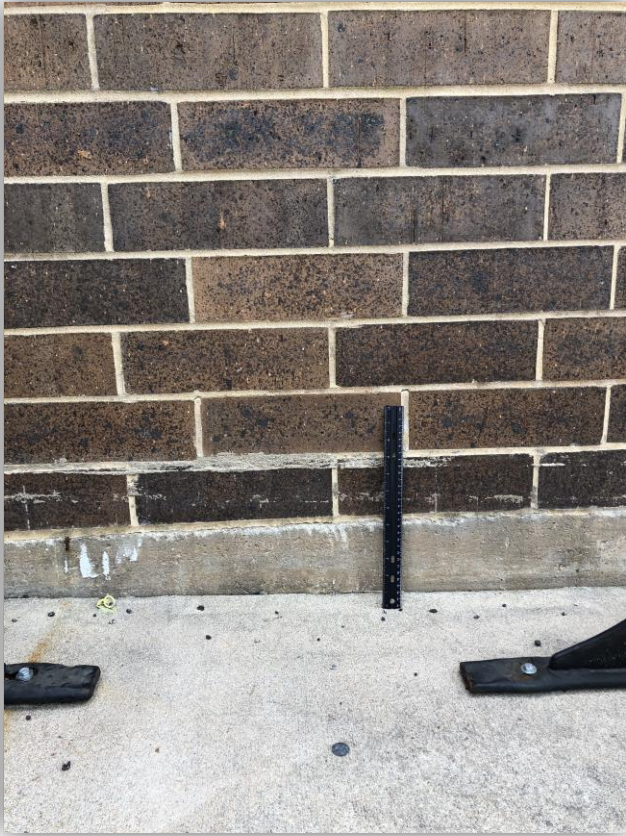
*The once-level pedestrian approaches are now considerably sloped, are no longer ADA compliant, and require asphalt patching.*

*The front entrance approach has sunk at least 9 inches, or an average of a quarter inch per year.*

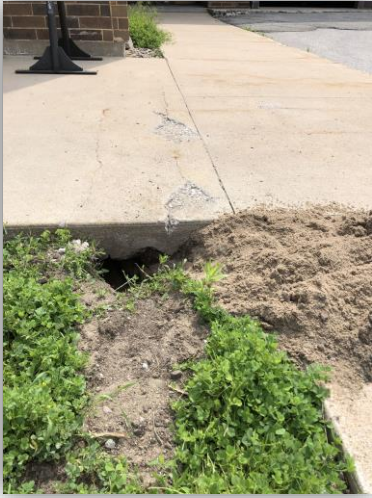
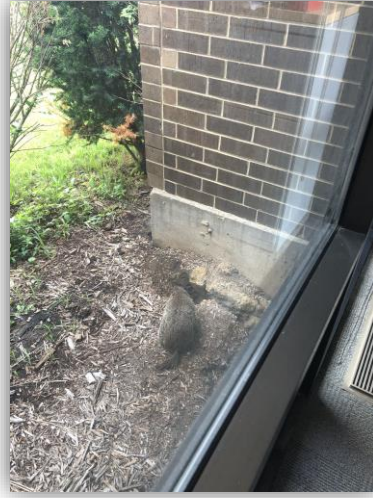
*Animals, such as this woodchuck, have taken up residence under the building which causes subsequent flea and other pest invasions.*
