# Survey and Evaluation Update

# Iowa City Central Business District

Prepared for
City of Iowa City
Iowa City Historic Preservation Commission

Prepared by
Alexa McDowell
AKAY Consulting
Minneapolis, Minnesota

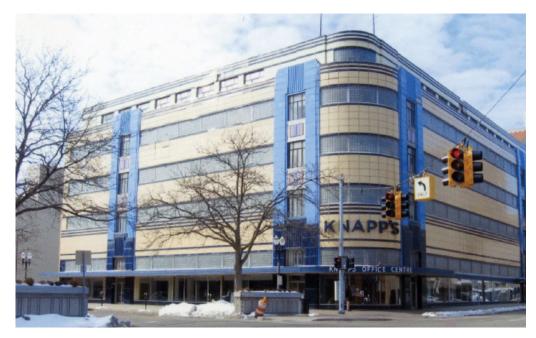
[7] (a) J.W. Knapp's Department Store, built 1937-38, in Lansing, MI, was constructed with a proprietary material named "Maul Macotta" made of enameled steel and cast-in-place concrete panels. Prior to its rehabilitation, a building inspection revealed that, due to a flaw in the original design and construction, the material was deteriorated beyond repair. The architects for the rehabilitation project devised a replacement system (b) consisting of enameled aluminum panels that matched the original colors (c). Photos and drawing (a-b): Quinn Evans Architects; Photo (c): James Haefner Photography.

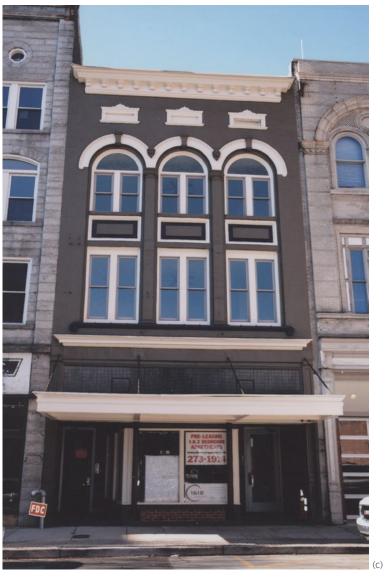
[22] **Not Recommended:** (a-b) The original wood windows in this late-19<sup>th</sup>-century building, which were highly decorative, could likely have been repaired and retained. (c) Instead, they were replaced with new windows that do not match the detailing of the historic windows and, therefore, do not meet the Standards (above).

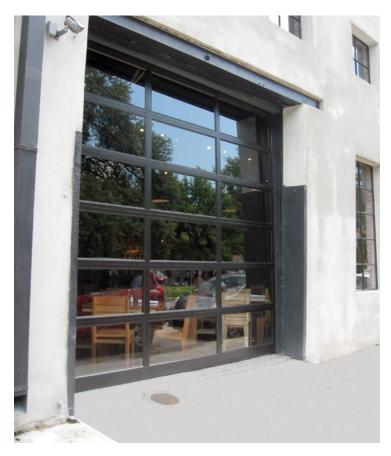
[25] The new infill designs for the garage door openings in this commercial building (a) converted for restaurant use and in this mill building (b) rehabilitated for residential use are compatible with the historic character of the buildings.

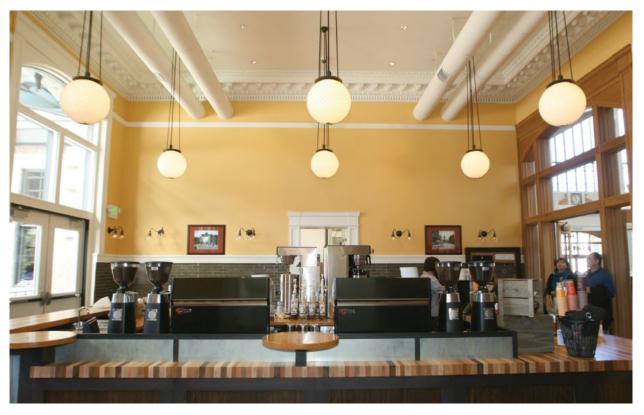
[37] Exposed and painted ducts were appropriately installed here in a retail space in Denver's historic Union Station after considering other options that would have impacted the ceiling height, or damaged or obscured the ornamental plaster crown molding. Photo: Heritage Consulting Group.

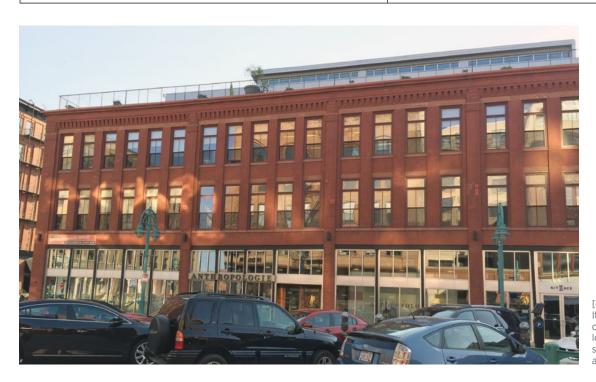
[64] **Not Recommended:**It is generally not appropriate to construct a rooftop addition on a low-rise, two- to three-story building such as this, because it negatively affects its historic character.

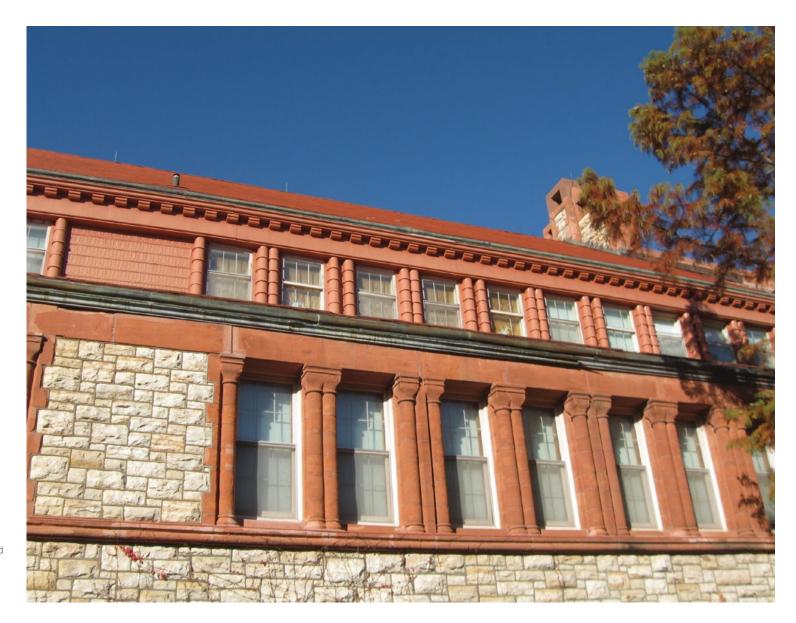
[6] Preliminary work before starting restoration revealed that the columns and the decorative shingles ornamenting the top floor of this historic building were fabricated of metal to imitate the red sandstone used elsewhere on the building.
