Site Inventory Form State Historical Society of Iowa (December 1, 1999)	State Inventory No. 52- Part of a district with Relationship: (1) Contributes to a pote National Register Status 9-Digit SHPO Review & Non-Extant (enter ye	known bounda Contributing ntial district wi (any that app Compliance N	☐ Noncontributing ith yet unknown boly) ☐ Listed ☐ Do	ry no.)

1. Name of Property				
historic name Market Hall				
other names/site number Franklin	Market building			
2. Location				
street & number 2-4 S. <u>Dubuque S</u> city or town <u>lowa City</u> Legal Description: (If Rural) Townsl (If Urban) Subdivision <u>Origina</u>	hip Name Tov	☐ vic wnship No. ─Block(s) 66		nson on Quarter of Quarter Lot(s) see add. info

7. Property Description

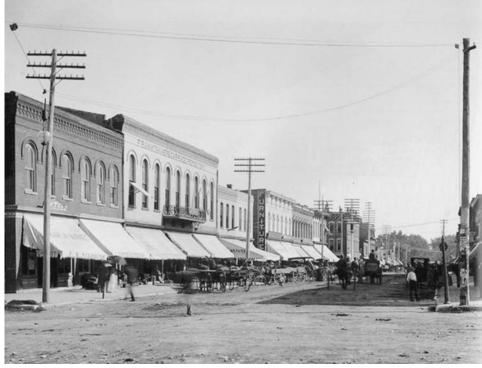
Image 01. Historic Image: View looking south along S. Dubuque Street from Iowa Avenue – 1894

Market Hall (aka Franklin Market building), constructed in 1873, replaced a ca.1856 three-story block building also known as Market Hall, which was destroyed by fire in 1868 (*Finials*, 133-35). At the time of its construction, the new building was a 2-story, double-wide brick commercial building featuring a unified façade (west elevation) with two storefronts (Image 01). The building has historically functioned with different businesses occupying the two storefronts (the north and south halves being without an interior connection) with the upper story having openings between the sections.

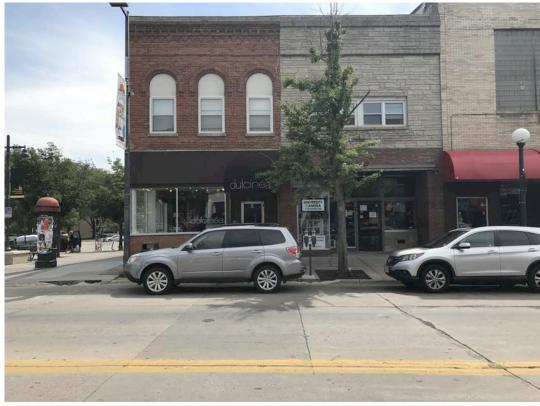
Image 02. View of the façade (west elevation), looking east across S. Dubuque Street.

Market Hall is located on the southeast corner of the intersection of E. Iowa Avenue and S. Dubuque Street. The 40-foot façade fronts S. Dubuque on the west, with its 82-foot depth running east to the alley; the secondary elevation faces Iowa Avenue. The building has two storefronts facing onto Dubuque Street with a rear entrance facing onto Iowa Avenue, allowing for use as a separate retail space. The building has a low stone foundation with masonry walls constructed of reddish brown brick.

The contemporary storefront in the north bay (2 S. Dubuque St.) has a recessed entrance at the right with a shop window wrapping around the storefront corner. The display window is smaller than the historic, made possible by the use of a 3-foot bulkhead (knee wall), which fills the remainder of the plane. Despite the diminished glazing, the storefront retains an open, commercial character. A fixed awning runs the width of the bay.

The storefront in the south bay (4 S. Dubuque St.) has an off-center, recessed entrance. While some alteration of the storefront is evident, sections of an earlier (likely mid-20th century) storefront are retained. This includes an L-shaped display area comprising the north portion of the storefront, up to the point it meets the door. The door and remainder of the storefront is a more recent alteration (post-dating the 2001 survey). The alteration retains a reasonable sense of openness that characterizes historic commercial storefronts, with a modified version of the typical bulkhead-glazing-transom configuration. The storefront is surrounded with a non-historic face brick and a retractable awning is mounted at the level of the storefront cornice.

The upper story of Market Hall was altered in ca.1947, resulting in a stylistic separation between the bays of the building. The upper façade of the north bay second floor retains a good level of integrity, remaining representative of its historic Romanesque influenced expression. The upper wall has three windows, each with stone sills and semi-circular brick arches. The brick cornice has several rows of corbeled brick in several distinct patterns. The original windows have been replaced with contemporary sash that are both undersized and do not follow the arched form of the historic opening.

In contrast, the upper façade of the south bay is representative of the mid-century renovation with Permastone cladding and the alteration of the fenestration, which is comprised of four small double-hung windows grouped on-center. Further, the building's original brick cornice has been covered with a projecting course of Permastone. While the alteration creates a separation of character from the historic, because the change dates to more that 50-years of age it should be considered historic in its own right and representative of the evolution of the commercial district.

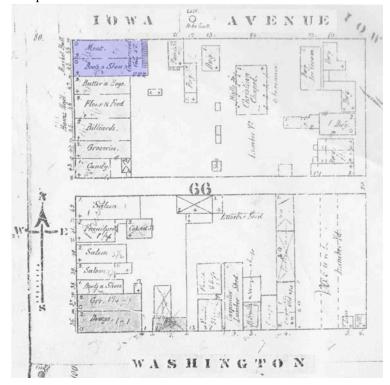
Figure 01. Fire Insurance Map – 1874

- 1874 Fire Insurance Map: North and south bays of upper story have an opening between them. No connection to the building adjacent on the south. South half o the upper story is occupied by a business college. The building name is noted as "Market Hall."
- 1883 Fire Insurance Map: North and south bays of upper story have an opening between them. No connection to the building adjacent on the south. South half o the upper story is occupied by a business college.
- 1888 Fire Insurance Map: North and south bays of upper story have an opening between them. No connection to the building adjacent on the south. South half o the upper story is occupied by a business college.

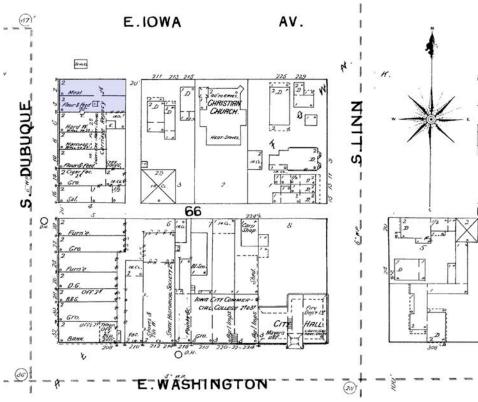
Figure 02. Fire Insurance Map – 1892

From ca.1892 to ca.1912 the upper floor of Market Hall was connected to the building adjacent to the south (6-10 S. Dubuque); in 1892 the adjoining building was Frank Tanner's Carriage Depository (*Sanborn Company Fire Insurance Maps* and *Finials*, 136).

- 1892 Fire Insurance Map: North and south bays of upper story have an opening between them AND a fire door between the south bay and the adjacent building (6-10 S. Dubuque). The upper story of all bays 2-10 S. Dubuque housed a carriage repository.
