Site Inventory Form
State Historical Society of Iowa
 (December 1, 1999)

historic name Ham's Hall (north two-thirds)

street & number 6-8 S. Dubuque Street

Title
Iowa City Central Business District Study - 2017 UPDATE

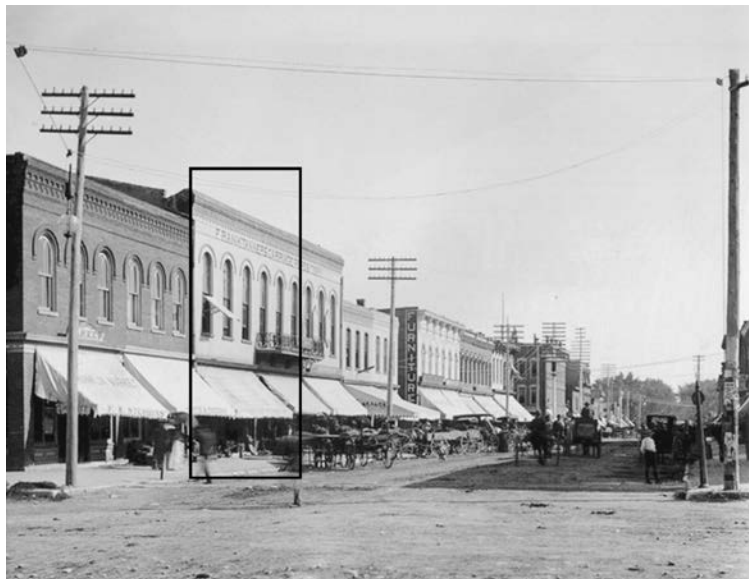
Image 01. Historic Image: View looking south along S. Dubuque Street from Iowa Avenue – 1894

The portion of Ham's Hall addressed here is indicated – the remainder of the building now functioning independent of the historical, three storefront block building.

Ham's Hall was constructed in ca.1873 as a two-story, brick commercial block (Image 01). At the time of its construction, the building featured a unified façade with three storefronts and an upper story façade that was dominated by nine, tall and narrow windows with rounded heads. The upper story was interconnected through at least 1912, but fire insurance maps suggest that by 1926 the interior connections between the middle and south bays were closed at both levels; a change in function of the upper story supports a move toward the sub-division of the building.

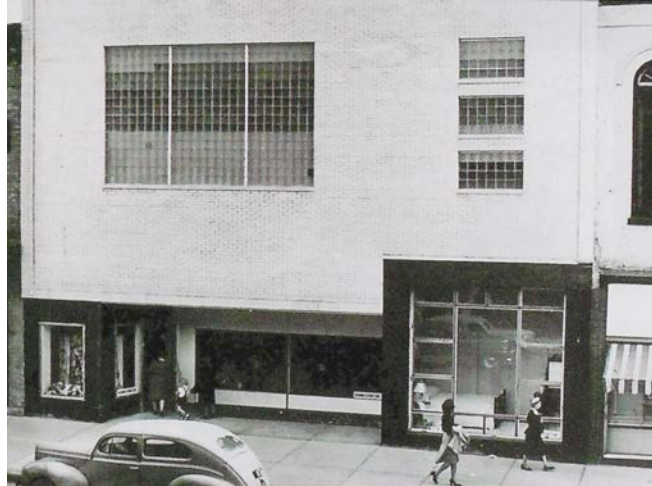
Image 02. Historic Image: View looking south along S. Dubuque Street from Iowa Avenue – c.1930

This image dating to ca.1930 illustrates the important and dynamic visual interplay between the upper façade and storefront. While changes to storefronts (such as the one reflected in the building today) are typical of downtown commercial buildings, because the expression of the ca.1930 modernization relied on the visual interplay of the storefront with the upper story façade, loss of the storefront makes a significant, adverse impact to the historic integrity specific to this version of the building – a shame really, because as a whole the alteration was very dynamic.

Today, the building façade reflects the separation of the north two bays from the south bay. By ca.1930, the north two-thirds of the building had been renovated; the upper façade is a product of that renovation (Image 02).The storefront was likewise remodeled in ca.1930 (Svendsen, 2001), though it has since been significantly altered.

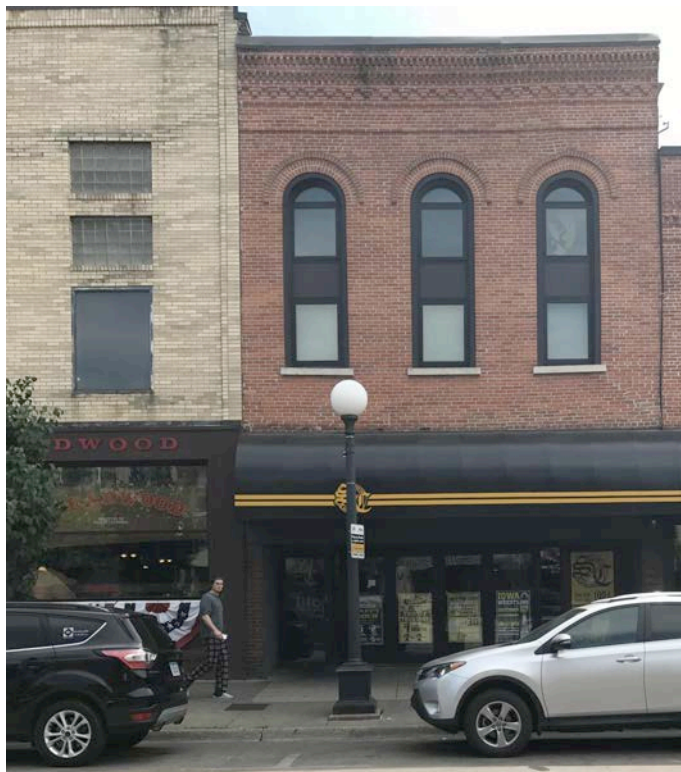
Image 04. View of the meeting of the two formerly conjoined sections of Ham's Hall

View of the resource adjacent to the remainder of the original Ham's Hall (10 S. Dubuque St.)
