# Iowa City Transit Facility – Existing Conditions

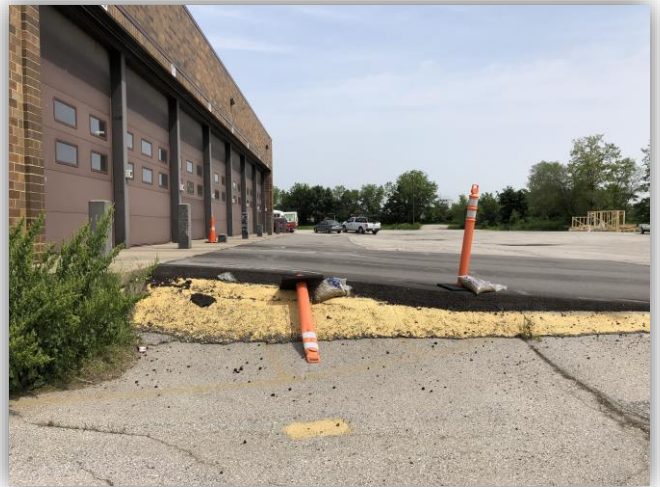
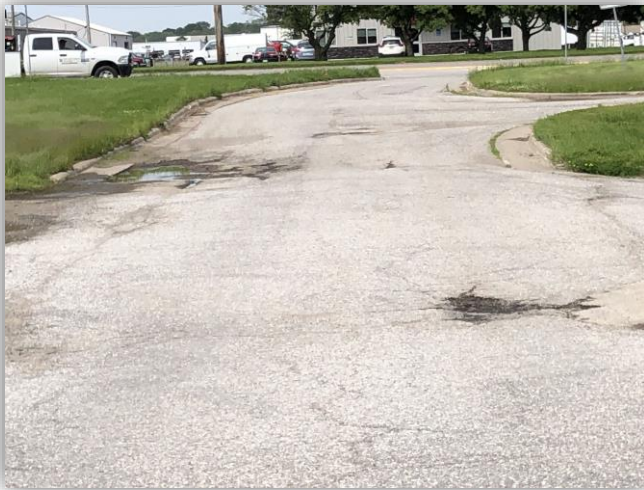
*Annual asphalt patching required to ensure buses have an adequate slope to enter/exit the building.*

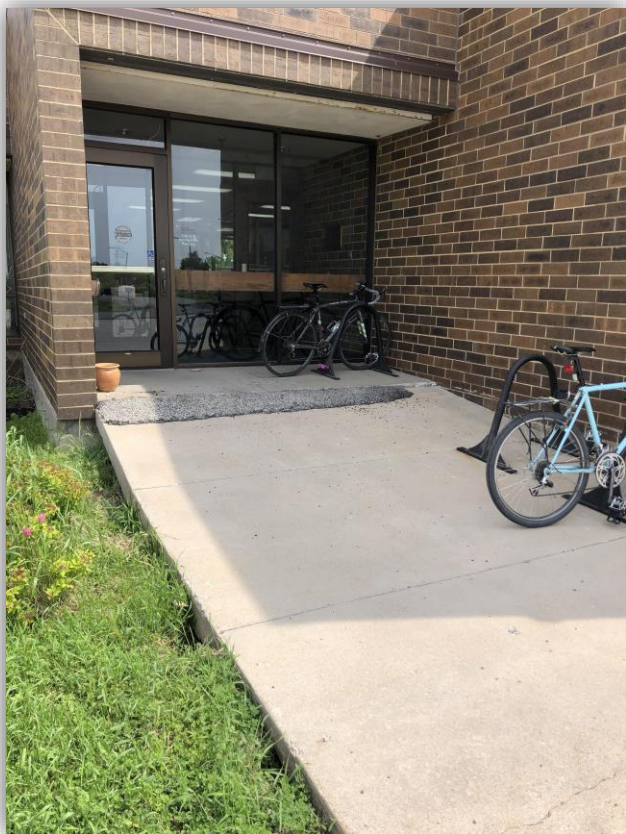
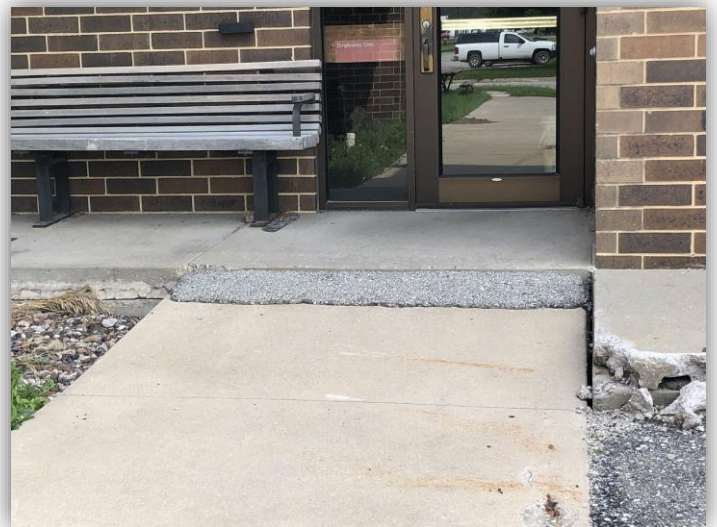
*The once-level pedestrian approaches are now considerably sloped, are no longer ADA compliant, and require asphalt patching.*

*The front entrance approach has sunk at least 9 inches, or an average of a quarter inch per year.*
