## **Towards a Resilient Future: Restoration of Ralston Creek within Riverfront Crossings Park**

**JUNE 2016  
EPA 832-R-16-003**

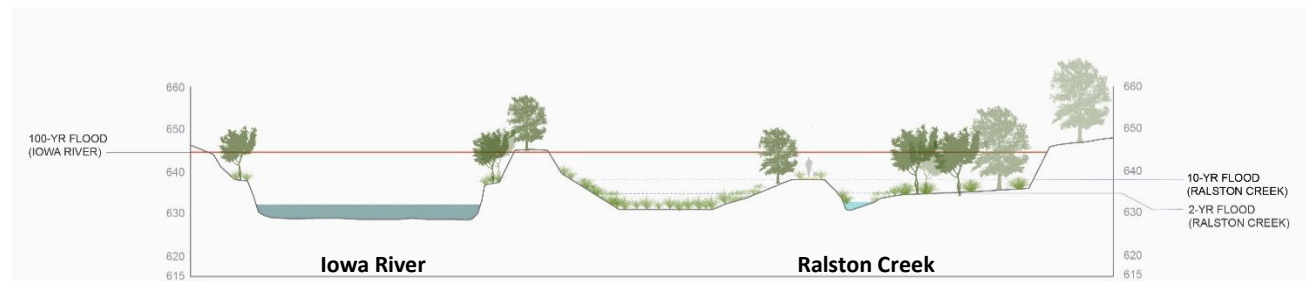
Figure 14. Conceptual Rendering of Restoration Cross Section.

The approach to the conceptual design of the Iowa City restoration site was to re-create the historic floodplain conditions and establish an off-channel wetland to maximize water quality treatment during frequent storm events. This approach requires the establishment of multiple elevations that replicate the functionality of typical floodplain systems in the region, while stabilizing entry and exit points for flows from both Ralston Creek and the Iowa River. Ultimately, the functionality of the flood flow and water quality components of the site should seamlessly integrate with the other proposed modifications and amenities of the park site to encourage public interaction and environmental education in all portions of the reclaimed treatment facility site. Figure 14 shows a cross section of the proposed restoration design for Ralston Creek and the off-channel wetland area.

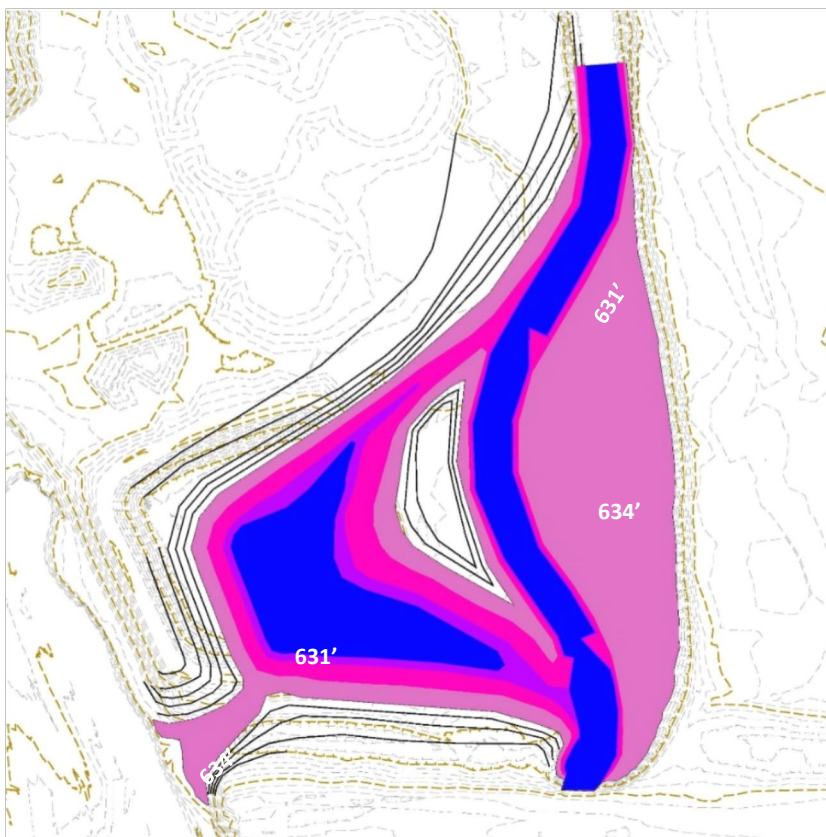
Figure 16. Site Inundation under Flood Conditions.

While the ultimate size of the wetland portion depends on available ground water hydrology, a minimum of one-half acre of permanent wetland area located at an elevation of 631 ft is proposed. This permanent wetland area could expand to 1 acre depending on ground water and overbank flow availability. Significant water quality improvements are not limited to the permanent wetland area. As the water surface elevation increases, flows access larger portions of the site, which causes filtering and uptake processes to occur. Figure 16 shows the inundation of the site under flood conditions. The permanent wetland area under normal flow conditions (631 ft, shown in blue) is approximately one-half acre. As the water surface elevation increases to 634 ft (between the 1- and 2-year events), flows inundate more than 1 acre of the site. At 634 ft, flood flows access nearly 4 acres of the restored site. Under current conditions, the banks of Ralston Creek at that elevation would still confine the flows; however, under restored conditions, there is the possibility for greater water quality benefits through physical, biological, and chemical processes.

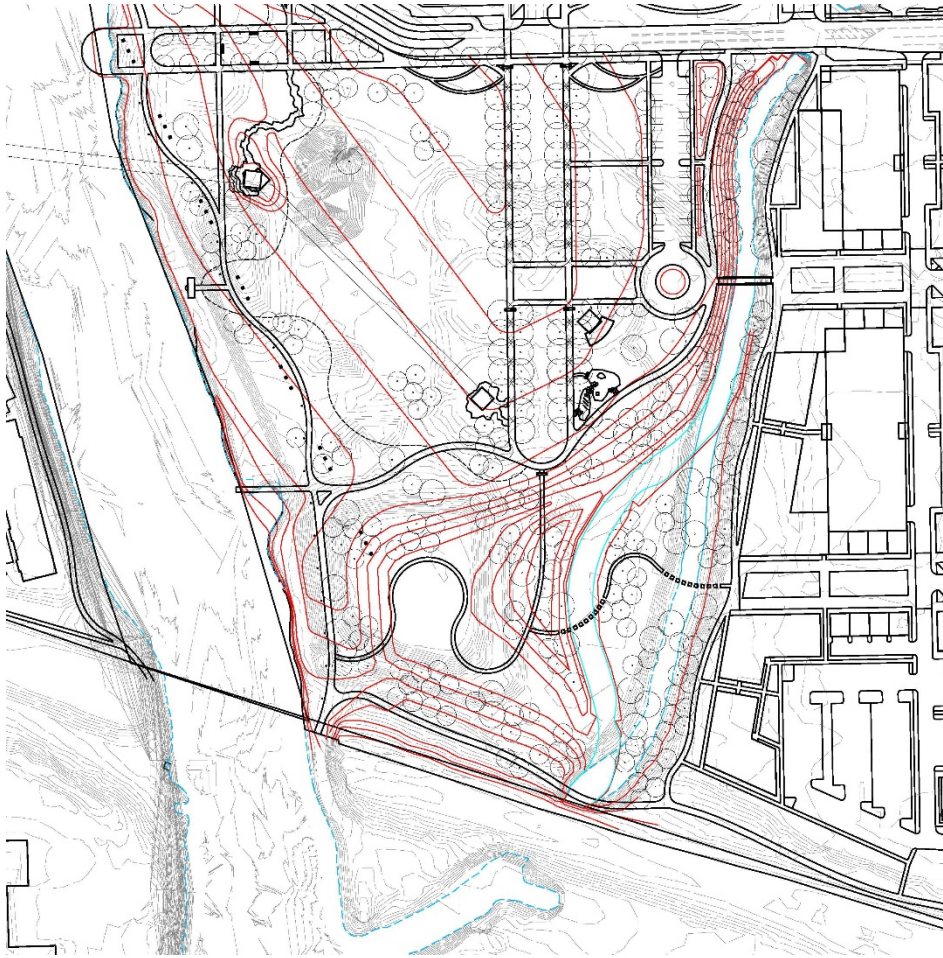
**Figure 22. Proposed Concept for Riverfront Crossings Park.**

A frequent comment at public outreach events for the park project is the desire to obtain better public access to the water. Accordingly, a trail system is proposed that takes advantage of multiple viewpoints over the Iowa River, Ralston Creek, and the restored wetland area. The trail system will bridge high points and include lower sections that will allow users to explore the wetland. Although the main entrances to the proposed park will be located at the north end, away from the restoration area, low-water crossings of Ralston Creek using natural rock boulders are included in the conceptual stream restoration design to allow more informal access points from the anticipated mixed-use area to the east of the creek. Residents and visitors will be able to access the proposed park from the planned redevelopment area through a path that will travel through the restored floodplain area and across the low-water crossing, providing a direct connection to the restored area.
